## MRI Artifacts

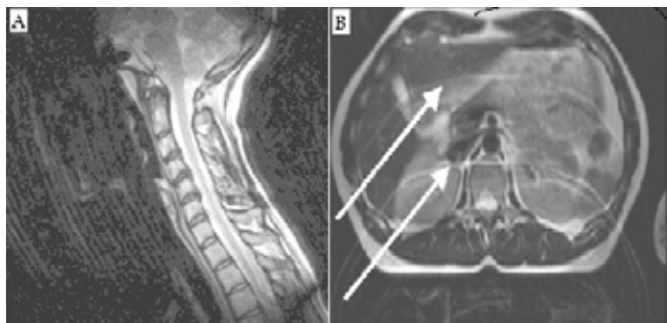
**Fig. 1.** Motion artifact  
**A.** Sagittal T2-weighted image of the cervical spine with pulsation artifact.  
**B.** Axial image of the abdomen showing motion artifact.

**Motion-related artifact:** Motion artifacts occur as a result of movement of tissue during the data acquisition period due to respiration, pulsation or motion, through the gradient magnetic field, hence acquiring an additional phase shift. They are manifested as signal misregistrations in the phase encoding direction than the readout direction because the encoding of phase by GPE occurs prior to signal detection.<sup>5</sup> An example of motion artifact is clarified in Figure 1.

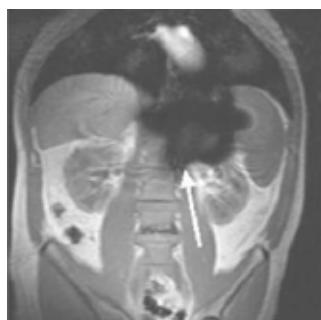
**Fig. 4.** Coronal MRI image of the abdomen showing susceptibility artifact.

**Susceptibility artifact:** Susceptibility is the ability of substances to be magnetized, e.g. iron in blood.<sup>8</sup> Susceptibility artifacts are caused by local magnetic field inhomogeneity. Tissues (cortical bone) or air-filled organs (lungs or bowel) contain little polarizable material and have very small susceptibility values. Soft tissue has a greater degree of polarization and a larger susceptibility. At the interface between soft tissues and the area of different susceptibility, a significant change in the local magnetic field is present over a short distance, causing an enhanced dephasing of the protons located there (Fig. 4).

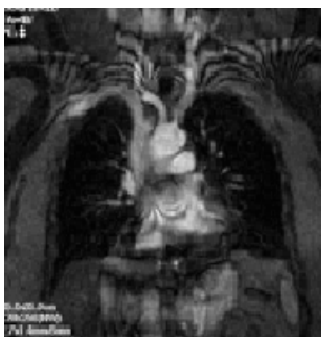
**Fig. 7.** Coronal MRI image of the chest showing zebra artifact.

**Zebra artifact:** It occurs when patients touch the coil, or as a result of phase wrap (Fig. 7). Making sure the patient is not touching the receive coil and using the no-wrap option may prevent this problem.
