Case Report

An Extremely Rare Complication of Ureteral Pigtail Stent Placement: A Case Report

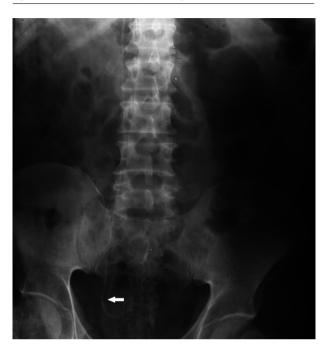
Figure 1. KUB After Placement of DJ Stent in Right Ureter

The X-ray revealed an abnormal pathway of the double-J stent that probably entered into the inferior vena cava. The arrow shows the position of the ureteral stone, 8 \times 6 mm in size, at the ureterovesical junction.

In this case, the surgeon blindly passed a 0.035 guidewire through the intramural ureter, when it probably passed into the submucosa and then the iliac vessel. Several methods can help to reduce the risk of such migration. First, the guidewire should not be forced blindly through the ureter. Second, use of hydrophilic wire can

prevent passing the wire into the submucosal layer. Moreover, DJ stent insertion under fluoroscopic guide can reduce these complications. In the absence of fluoroscopy, postoperative X-ray should be considered. If abnormal position of the stent is suspected, other diagnostic methods, such as CT with IV contrast, can confirm or disprove the diagnosis. Finally, clinicians should pay attention to warning symptoms of the patient, such as significant hematuria and severe abdominal pain.

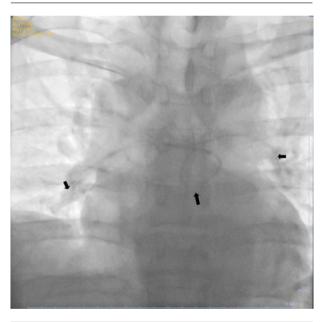
$\textbf{Figure 3.} \ \ \textbf{Fluoroscopic View of Pulmonary Angiography Showed that the DJ Stentwas Completely in the Pulmonary Artery}$

giography department. In fluoroscopy, during pulmonary angiography, the DJ stent was seen completely in the pulmonary artery. The tip of the stent was fixed, which may have been due to wedging in the pulmonary artery branch, thrombus formation in this site, or other causes (Figure 3). Other laboratory data including CBC, BUN, ESR, CRP, and creatinine were normal. Blood culture was requested, and prophylactic antibiotic and anticoagulant therapies were performed for the patient. Further, the literature was reviewed for management in such situations. There are two methods to remove endovascular foreign bodies: open surgery and intravascular retrieval (5-9), and it was planned to remove the stent percutaneously. 10 French right femoral sheath was used, and pulmonary angiography was performed (Figure 4). A multipurpose 7F catheter was used to try to release the fixed left tip of the stent, but frequent manipulation was not successful. The right distal tip of the stent was captured by peripheral snare, and the stent was retrieved successfully without any complication. BUN and creatinine after angiography and procedure were normal. The patient was discharged in good condition. After six months follow-up, he had no symptoms.

In this case, the stent was completely in the pulmonary arteries. Multiple treatment options can be used for this situation, such as percutaneous removal by snare catheter, when possible, and open surgery. Because of the good condition of the patient and available expertise for endovascular intervention, it was decided to remove the stent by the endovascular method with femoral access. If expertise for endovascular intervention is not available, open surgical removal is an alternative, safe method. Intravascular migration of DJ stents is a rare but serious complication. When there is doubt, complementary diagnostic procedures and early intervention are recommended. Percutaneous removal of a migrated stent under fluoroscopic guidance by snare catheter from femoral access is a safe and effective treatment.

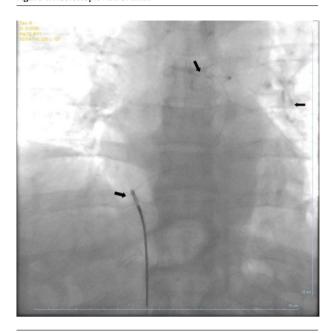
Figure 4. Fluoroscopic View of Chest

When the peripheral snare was introduced percutaneously from the femoral sheath, and the tip of the stent was captured by it.
